**STONYBROOK CREEK SALMONID
MIGRATION BARRIER
REMOVAL PROJECT**

December 2005

American Rivers
and
California State Coastal Conservancy

This report summarizes the conceptual designs developed for removal and replacement of two road-stream crossings on Palomares Road at post mile 8.60 and 8.75. The assessment of the downstream crossings is described in a separate report.

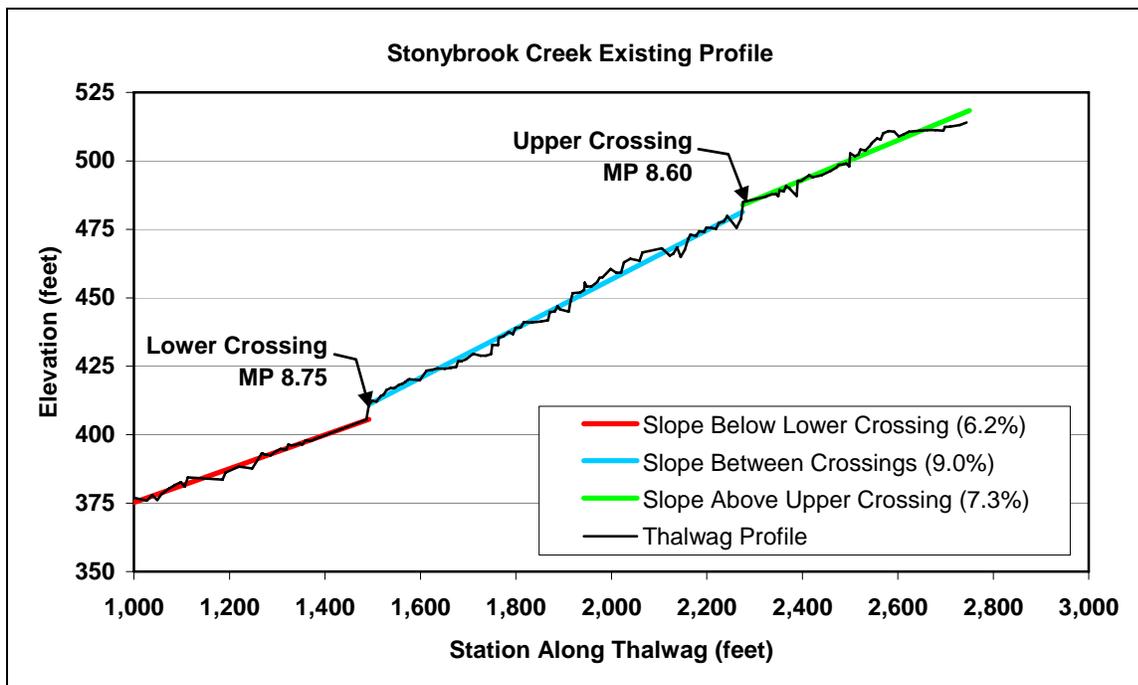
Figure 2.1 - Figure 1 – Longitudinal profile of Stonybrook Creek through the project area. Slopes were estimated using linear regression of surveyed thalweg points, excluding the culverts.

Surveying a longitudinal profile through the project site is essential for developing successful channel designs. Since the two crossings are less than 800 feet apart, we chose to survey one long continuous profile. It extended over 1,700 feet, beginning 455 feet below the downstream crossing to 400 feet above the upstream crossing. The average slope of the surveyed channel was 8.7 percent. However, the slope varied substantially above and below each of the crossings, ranging between 6.2 percent below the downstream crossing to 9.0 percent between the two crossings (Figure 1).

Upstream of the downstream crossing the channel appears severely aggraded with large boulders. The boulders have deposited at the culvert inlet due to the channel constriction caused by the undersized culvert. This creates a 5.5 foot drop in the channel bed immediately upstream from the culvert inlet which completely blocks fish passage and reduces the culvert's capacity (Figure 2). The deposition above the culvert also appears to have starved the downstream channel of the larger bedload sizes.

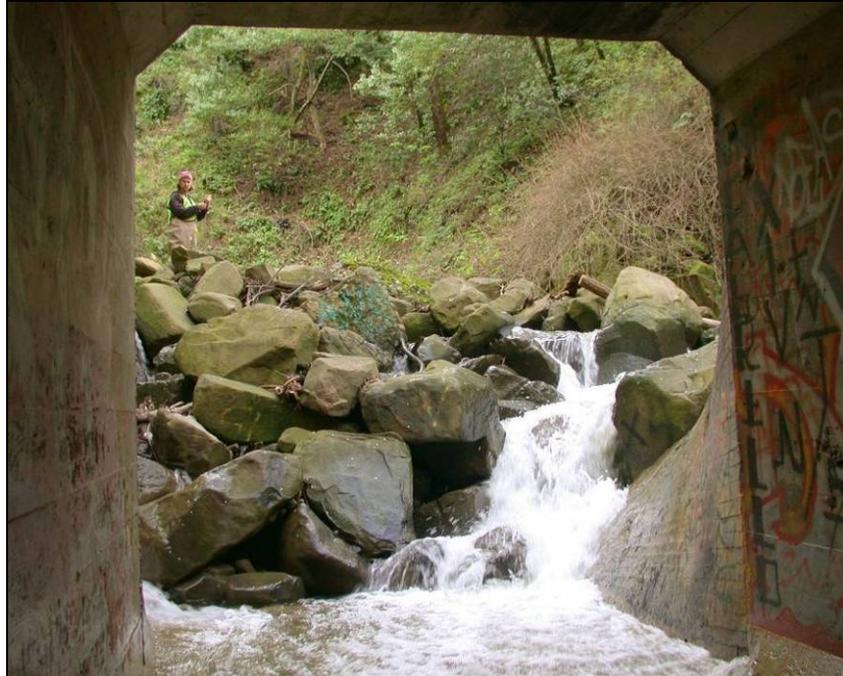
Figure 2.2 - Inlet of the downstream crossing (MP 8.75), as flow cascades down a 5.5 foot drop over boulders deposited due to the channel constriction caused by the culvert.

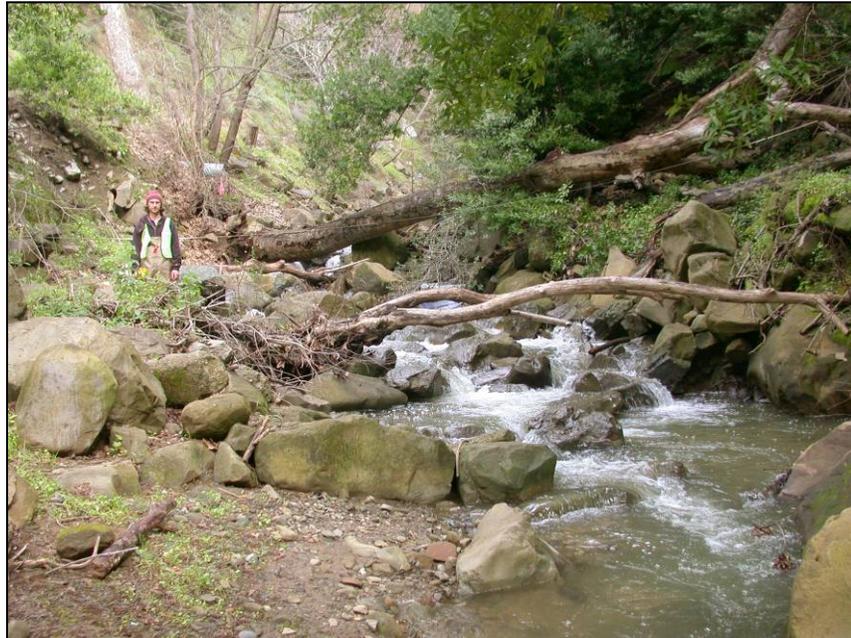
Figure 2.3 - Location of the reference reach, 200 feet upstream of the downstream crossing (MP 8.75)

As part of the design process a reference channel reach was located roughly 200 feet upstream of the downstream crossing which appeared representative of the entire channel between the two crossings (Figure 3). Within the reference reach a Wolman pebble count was conducted to characterize the streambed material, a channel cross section was surveyed, and the water surface slope through the cross section was measured.

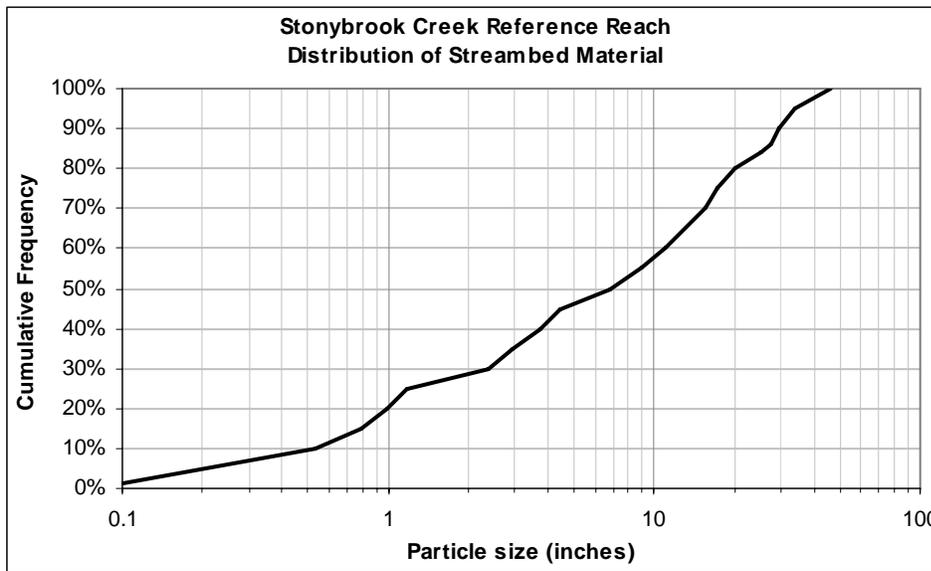
Figure 2.4 - Particle size distribution of streambed material located within the reference reach approximately 200 feet upstream of the downstream crossing.

To characterize the streambed material and aid in estimating appropriate hydraulic roughness, a particle size distribution was created from the pebble count. It found the d84 (84 percent of particles less than the d84) to be approximately 2 feet and the d50 to be nearly 7 inches (Figure 4). These values correspond with large bedload characteristic of a steep stream such as Stonybrook Creek. The material size and distribution is considered suitable for reconstructing step-pools into the regraded channel without needing to import large rock.

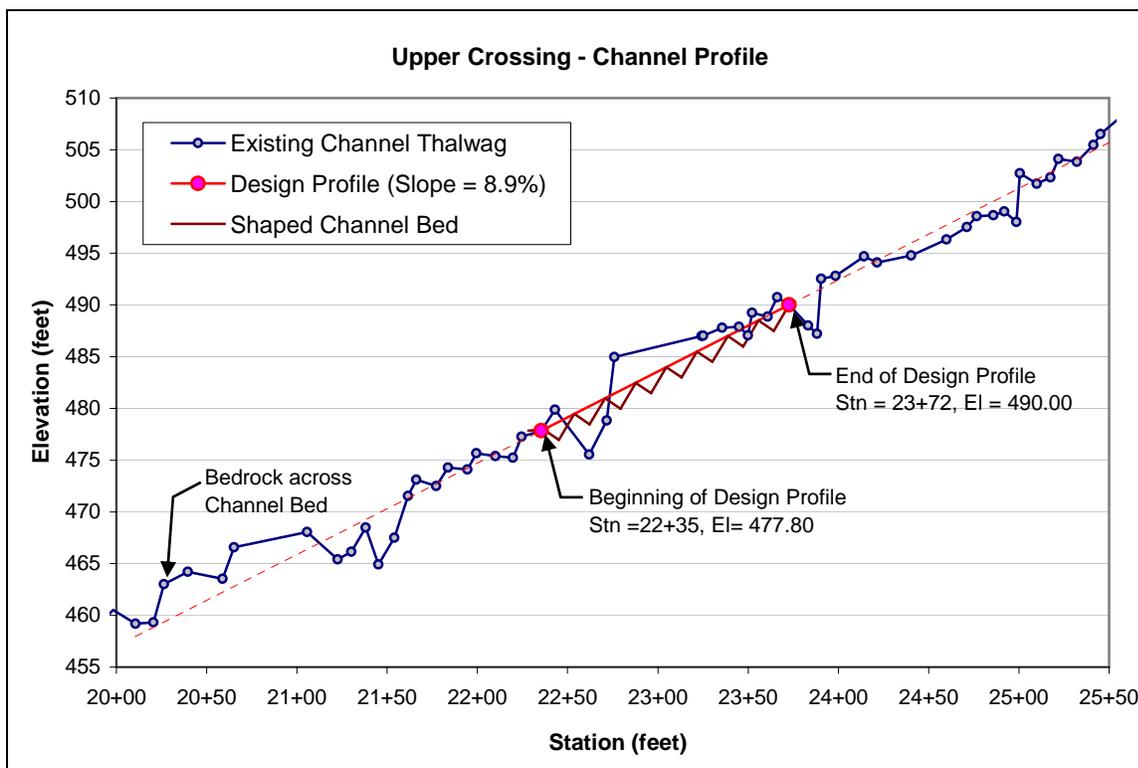
Figure 2.5 - Design channel profile for the upstream crossing at Mile Post 8.60.

Determining stable design slopes at the two crossings required examining the channel grade upstream and downstream, and identifying hard features in the channel that control the stream's grade. For the upstream crossing the stable channel slope is estimated to be 8.9 percent. The channel will be regraded from Station 22+35 to Station 23+72, a total of 137 feet to match the existing adjacent stream grades approximately 100 feet downstream and 200 feet upstream of the crossing (Figure 5). The survey also noted bedrock spanning the channel bottom at a location about two hundred feet downstream of the upstream crossing. Bedrock typically functions as a hard point in the channel, and is expected to prevent the streambed from incising below the upstream crossing following the replacement of the downstream crossing.

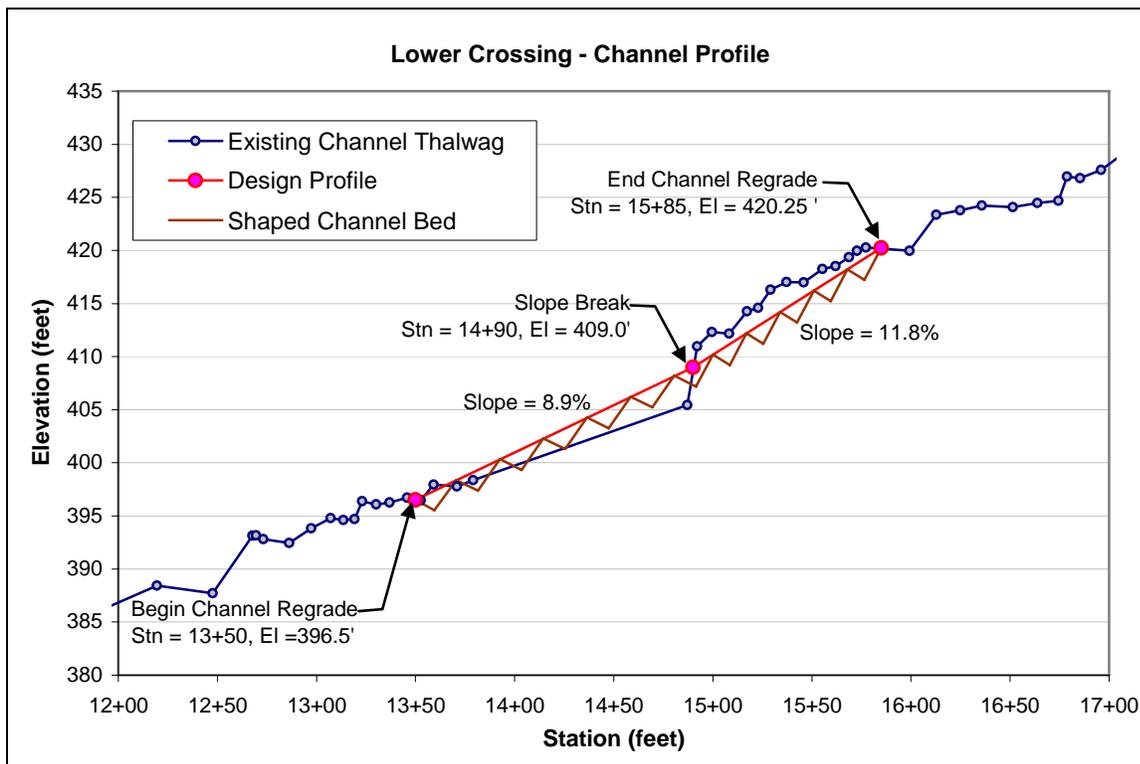
Figure 2.6 - Design channel profile for the downstream crossing at Mile Post 8.75.

at an average slope of 8.9 percent. At Station 14+90 there is a slope break and the design channel grade steepens to 11.8 percent. The regraded channel ends at Station 15+85, approximately 15 feet below a 4 foot high falls over an extremely large stable boulder that spans the channel. A slope break was needed to balance the amount of native streambed material available for grading.

We anticipate the stream shape and grade at the downstream crossing will adjust over time. Since both banks under the proposed bridge are bedrock, the channel adjustments will be confined and will not disturb the bridge abutments. Additionally, the bridge will be more than 20 feet above the channel bed, providing ample room for the bed to aggrade while maintaining adequate conveyance for the 100 year flow.

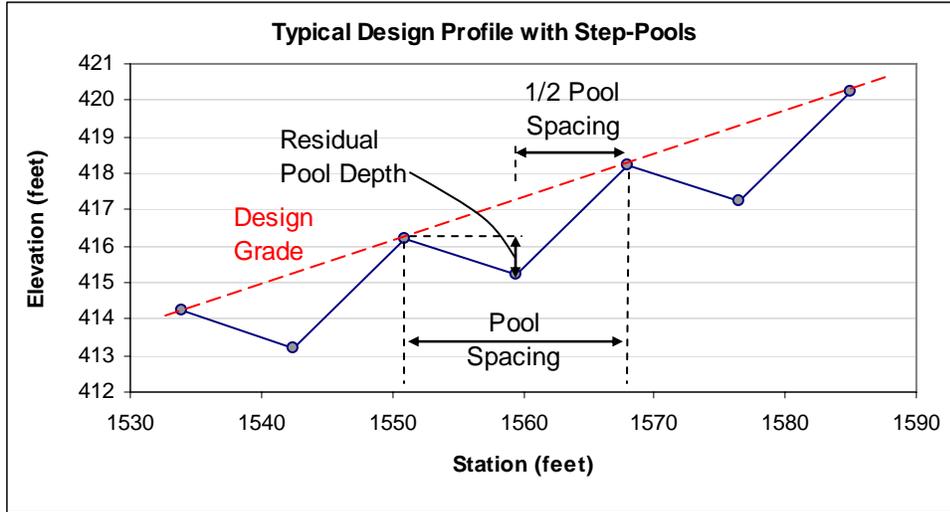
Figure 2.7 - Typical of step-pool configuration for regraded channel sections.

Since streams with slopes greater than 3 to 4 percent naturally either have a step-pool or cascade channel morphology, we propose to construct a rough step-pool shape into the finished channel bed. This will provide suitable fish passage conditions immediately after construction and assist the channel in setting up a stable step-pool configuration. However, we anticipate that substantial adjustment to the bed shape will still occur following construction.

The step-pool design is intended to be relatively easy to construct, provide suitable resting areas for fish, and be shaped in roughly the same configuration that is found in steeply sloping natural streams (i.e., 9 to 12 percent). Specified pool spacing for this project was determined through field observations of the adjacent channel and use of pool spacing relationships developed for other steep streams (Chin, 1999; Zimmermann and Church, 2001) (Figure 7 and Table 3). Additionally, each step pool must have a residual pool depth of one foot to provide adequate

resting area for fish. The steps will be constructed using native streambed material from the project site, which is comprised of large boulders as well as sands, gravels, and cobbles.

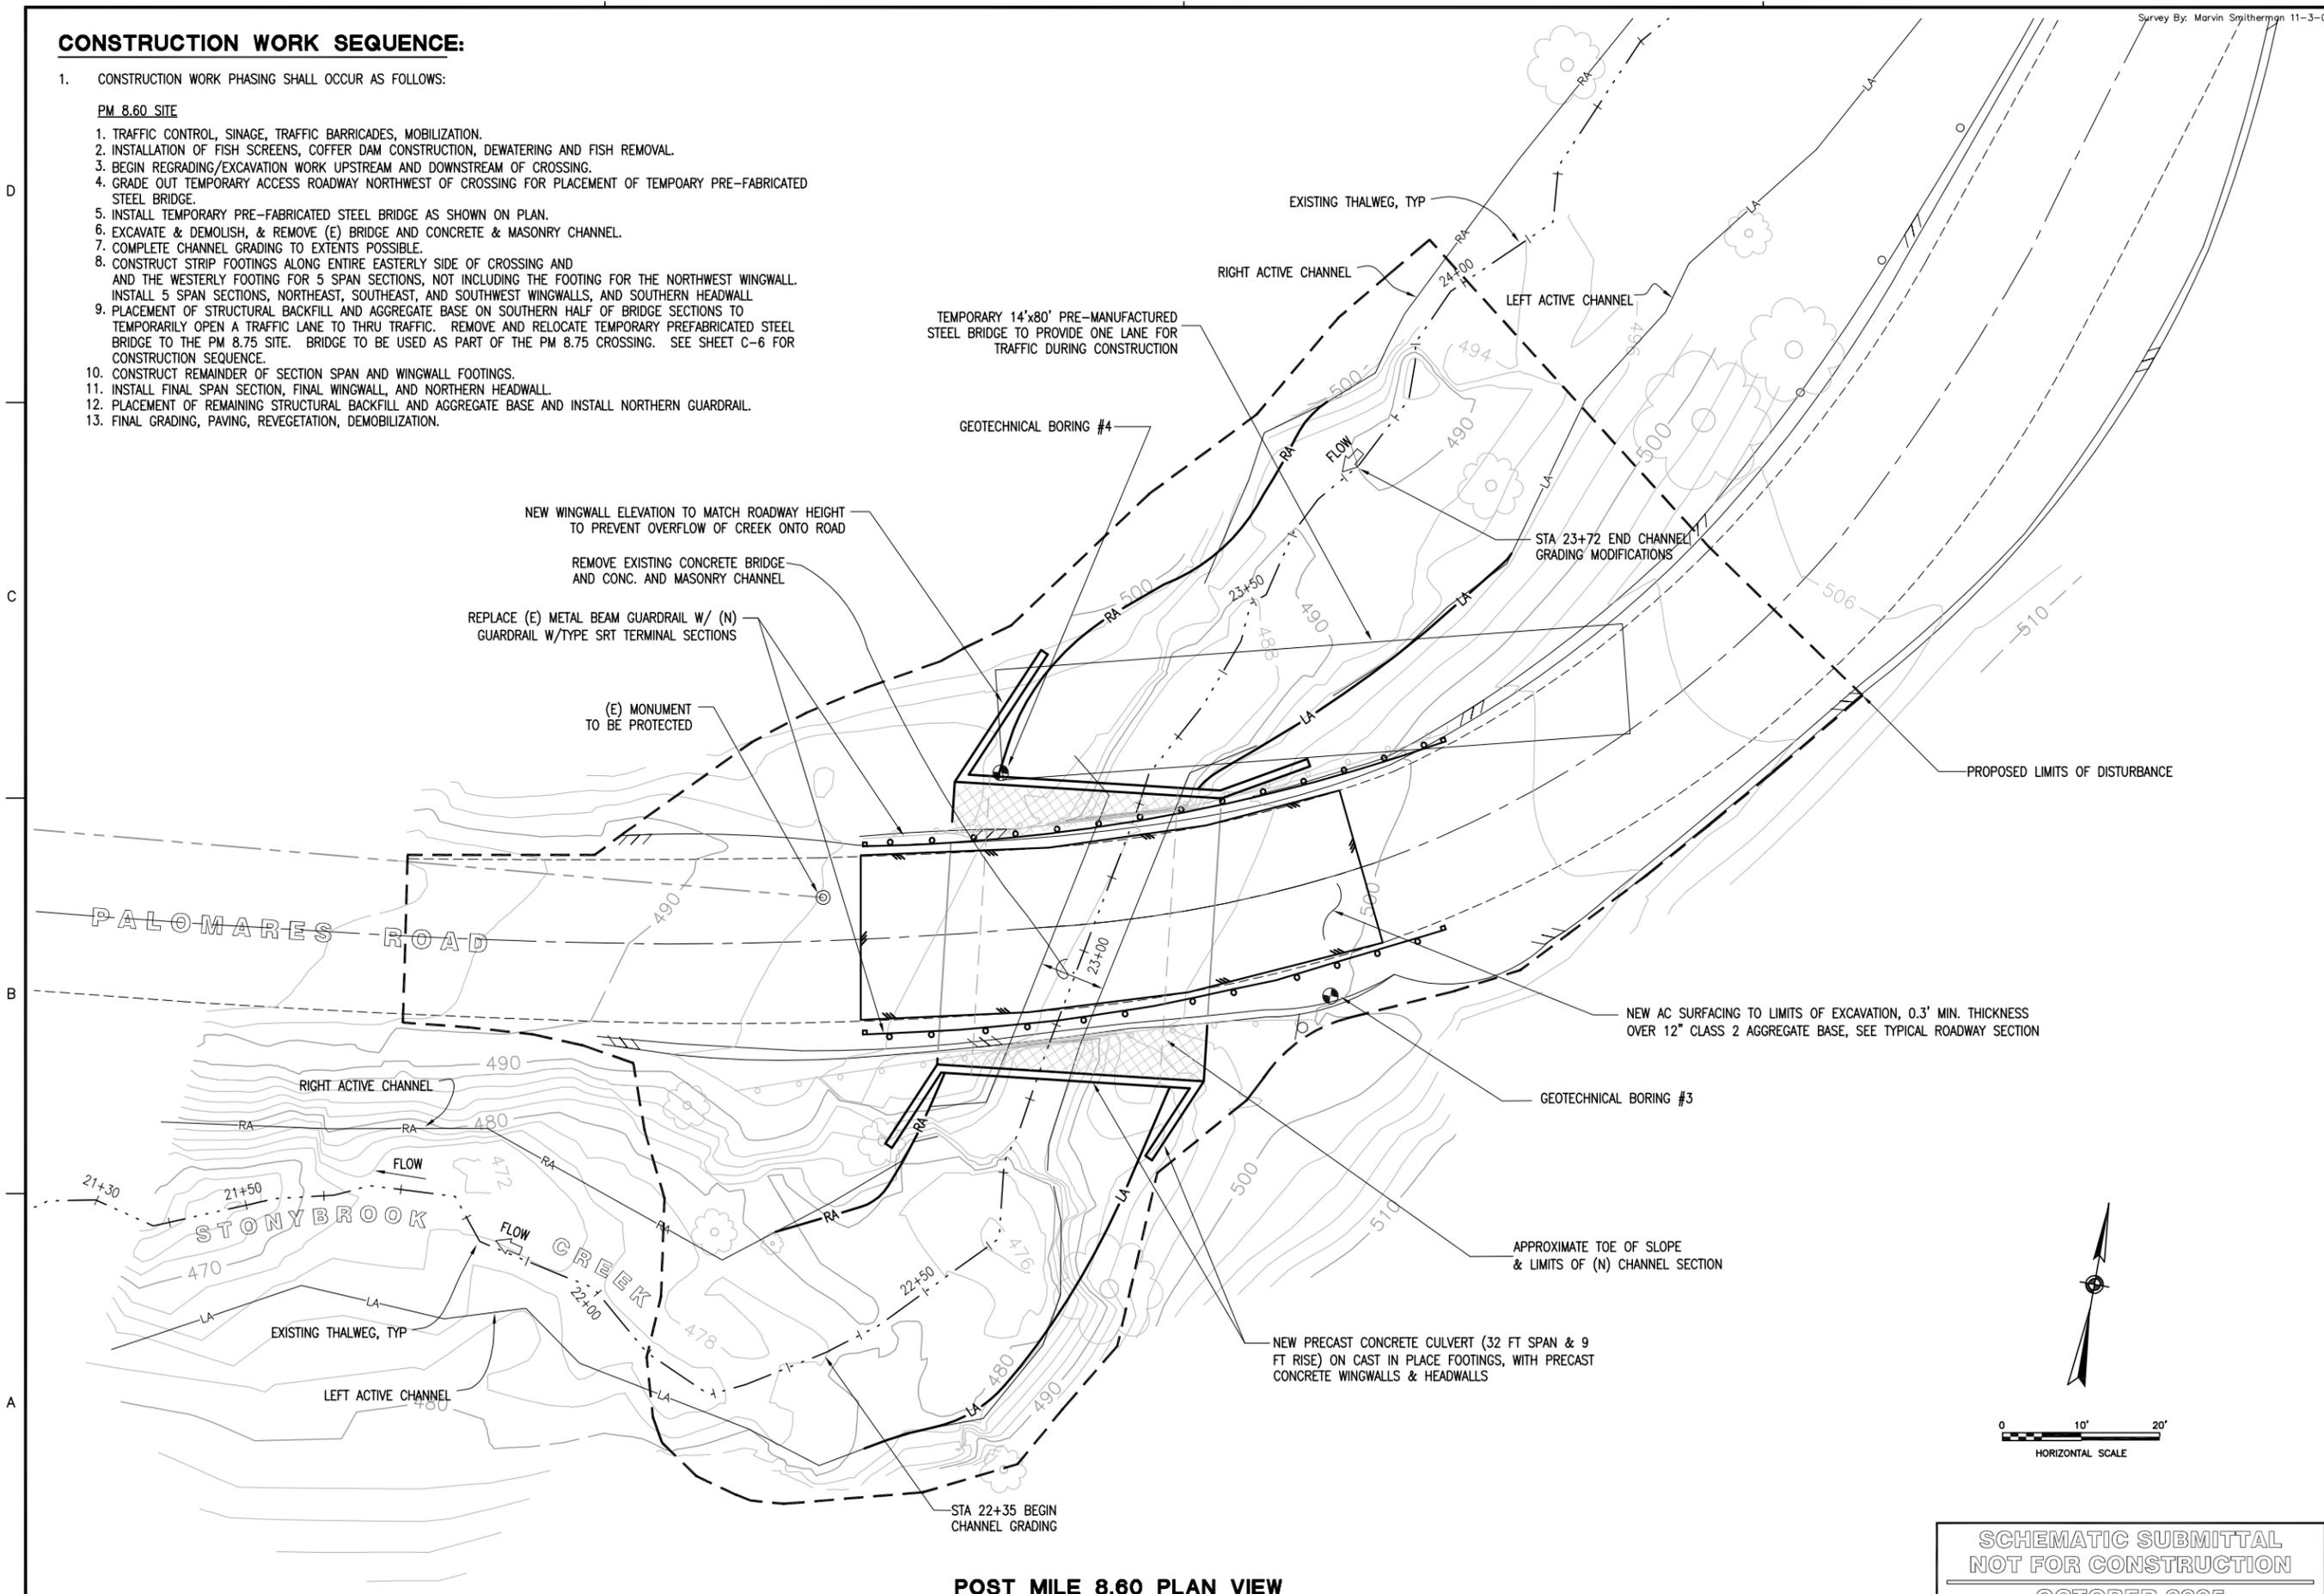
POST MILE 8.60 PLAN VIEW

10. CONSTRUCT REMAINDER OF SECTION SPAN AND WINGWALL FOOTINGS.
11. INSTALL FINAL SPAN SECTION, FINAL WINGWALL, AND NORTHERN HEADWALL.
12. PLACEMENT OF REMAINING STRUCTURAL BACKFILL AND AGGREGATE BASE AND INSTALL NORTHERN GUARDRAIL.

13. FINAL GRADING, PAVING, REVEGETATION, DEMOBILIZATION.

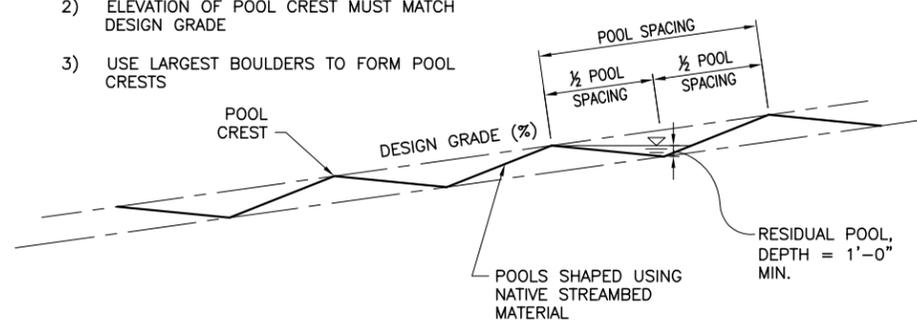
1 TYPICAL BED SHAPE
C-4.0, C-7.0|C-5.0 SCALE: NTS

- 1) BEDS FORMED BY MOVING NATIVE MATERIAL TO MATCH DIMENSIONS ON PLANS
- 2) ELEVATION OF POOL CREST MUST MATCH DESIGN GRADE
- 3) USE LARGEST BOULDERS TO FORM POOL CRESTS

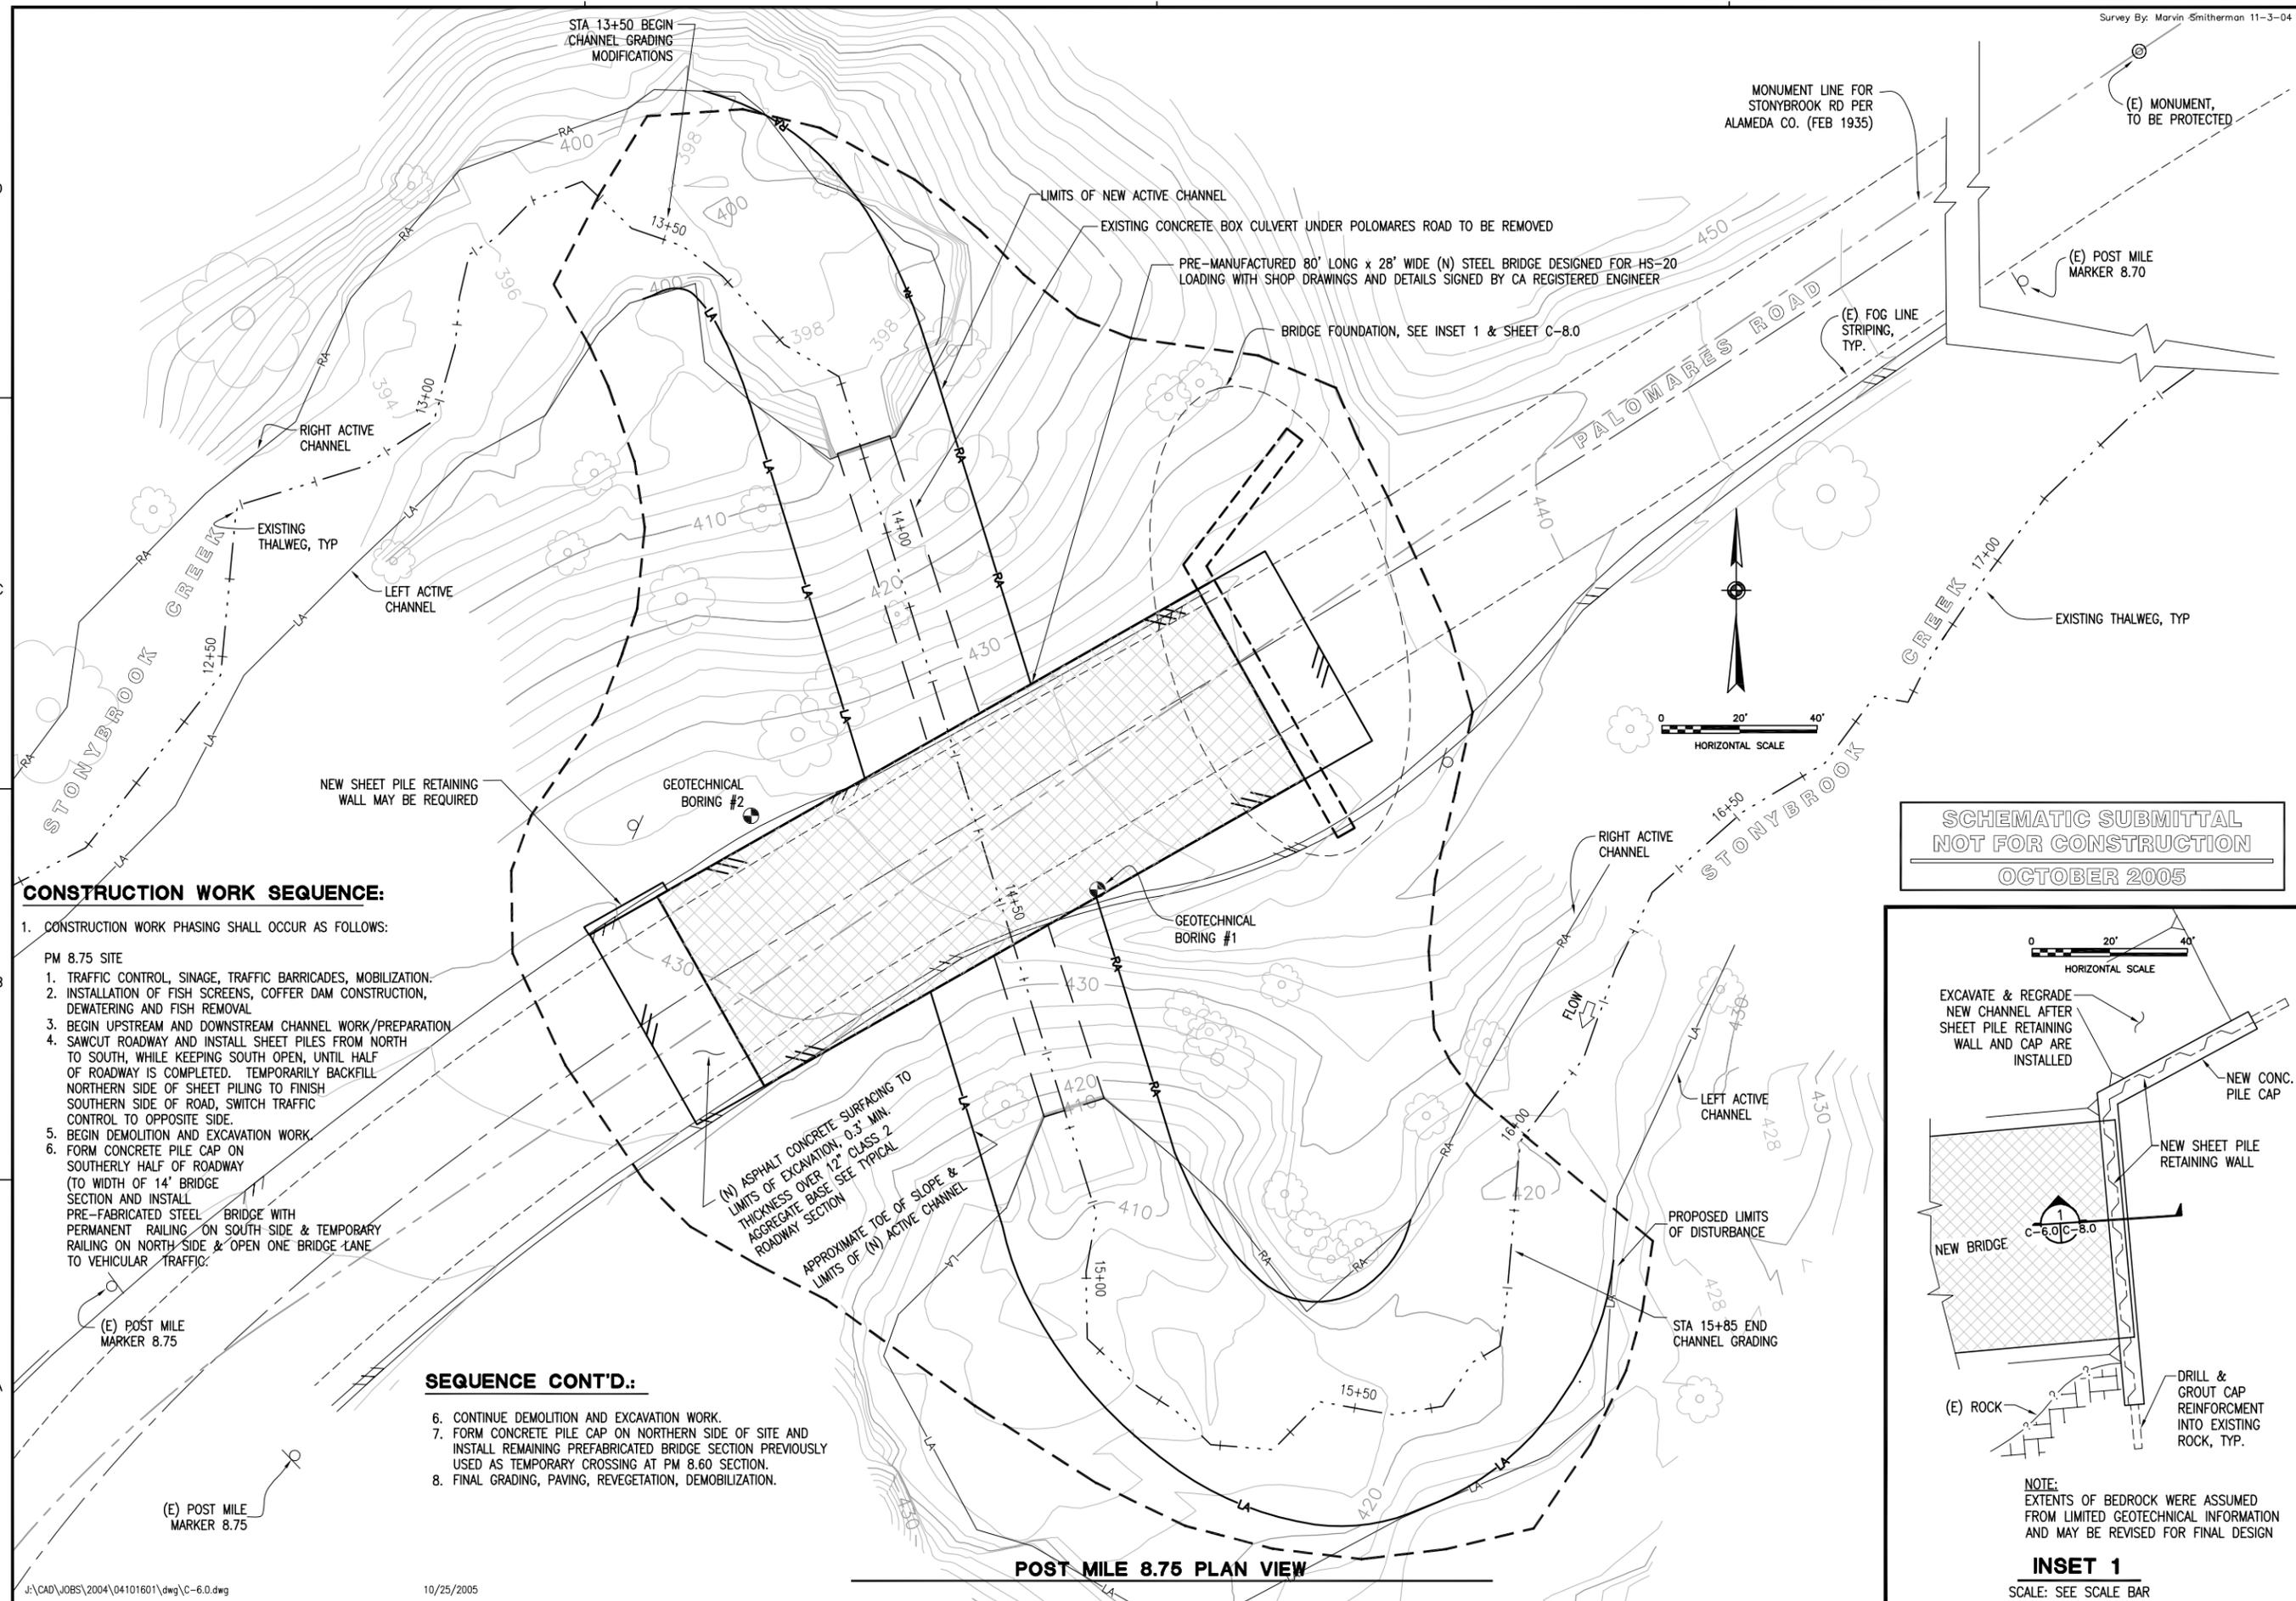
POST MILE 8.75 PLAN VIEW

1. CONSTRUCTION WORK PHASING SHALL OCCUR AS FOLLOWS:
- PM 8.75 SITE
 - TRAFFIC CONTROL, SINAGE, TRAFFIC BARRICADES, MOBILIZATION.
 - INSTALLATION OF FISH SCREENS, COFFER DAM CONSTRUCTION, DEWATERING AND FISH REMOVAL
 - BEGIN UPSTREAM AND DOWNSTREAM CHANNEL WORK/PREPARATION
 - SAWCUT ROADWAY AND INSTALL SHEET PILES FROM NORTH TO SOUTH, WHILE KEEPING SOUTH OPEN, UNTIL HALF OF ROADWAY IS COMPLETED. TEMPORARILY BACKFILL NORTHERN SIDE OF SHEET PILING TO FINISH SOUTHERN SIDE OF ROAD, SWITCH TRAFFIC CONTROL TO OPPOSITE SIDE.
 - BEGIN DEMOLITION AND EXCAVATION WORK
 - FORM CONCRETE PILE CAP ON SOUTHERLY HALF OF ROADWAY (TO WIDTH OF 14' BRIDGE SECTION AND INSTALL PRE-FABRICATED STEEL BRIDGE WITH PERMANENT RAILING ON SOUTH SIDE & TEMPORARY RAILING ON NORTH SIDE & OPEN ONE BRIDGE LANE TO VEHICULAR TRAFFIC.

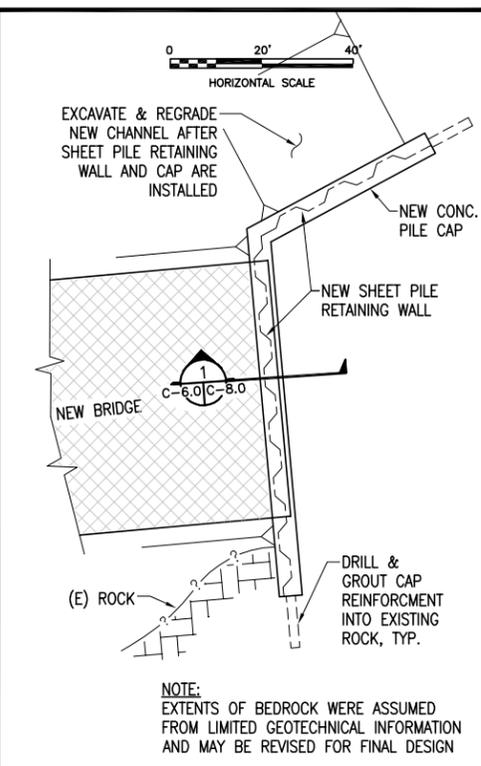
INSET 1
SCALE: SEE SCALE BAR

NOTE:
EXTENTS OF BEDROCK WERE ASSUMED FROM LIMITED GEOTECHNICAL INFORMATION AND MAY BE REVISED FOR FINAL DESIGN

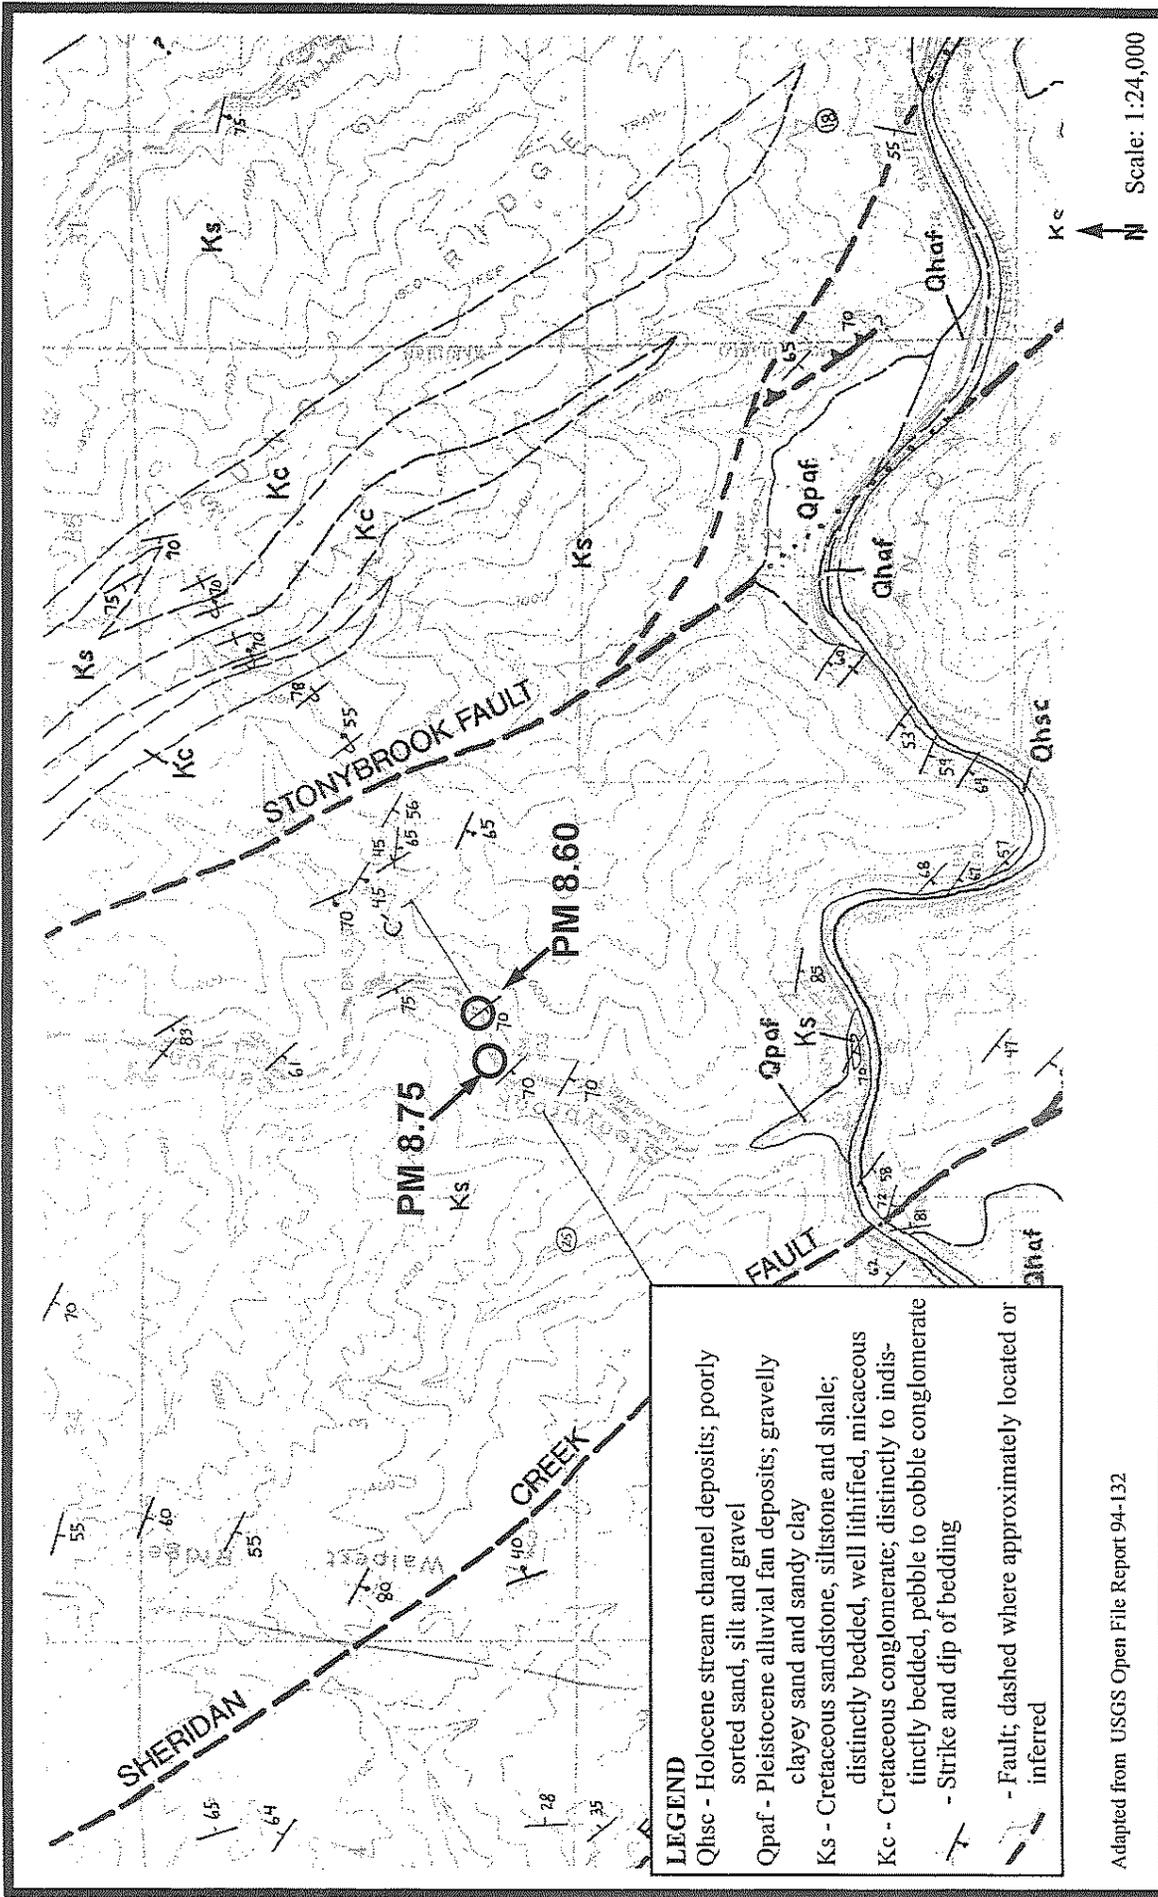
Job No: 562.1
 Date: March 2005
 Figure 2

Geologic Map

We observed rock consistent with the above description at both sites, as well as throughout the canyon in this vicinity. The canyon slopes are very steep (gradients up to 1:1 and steeper) and expose mostly bedded sandstone. The sandstone is moderately to slightly weathered and hard, with generally thick beds (greater than one foot). The sandstone is interlayered with thin (less than one inch) laminated and intensely fractured (“friable”) siltstone/shale beds. Rock bedding at both sites strikes uniformly northwest and dips generally 60-80° to the southwest.

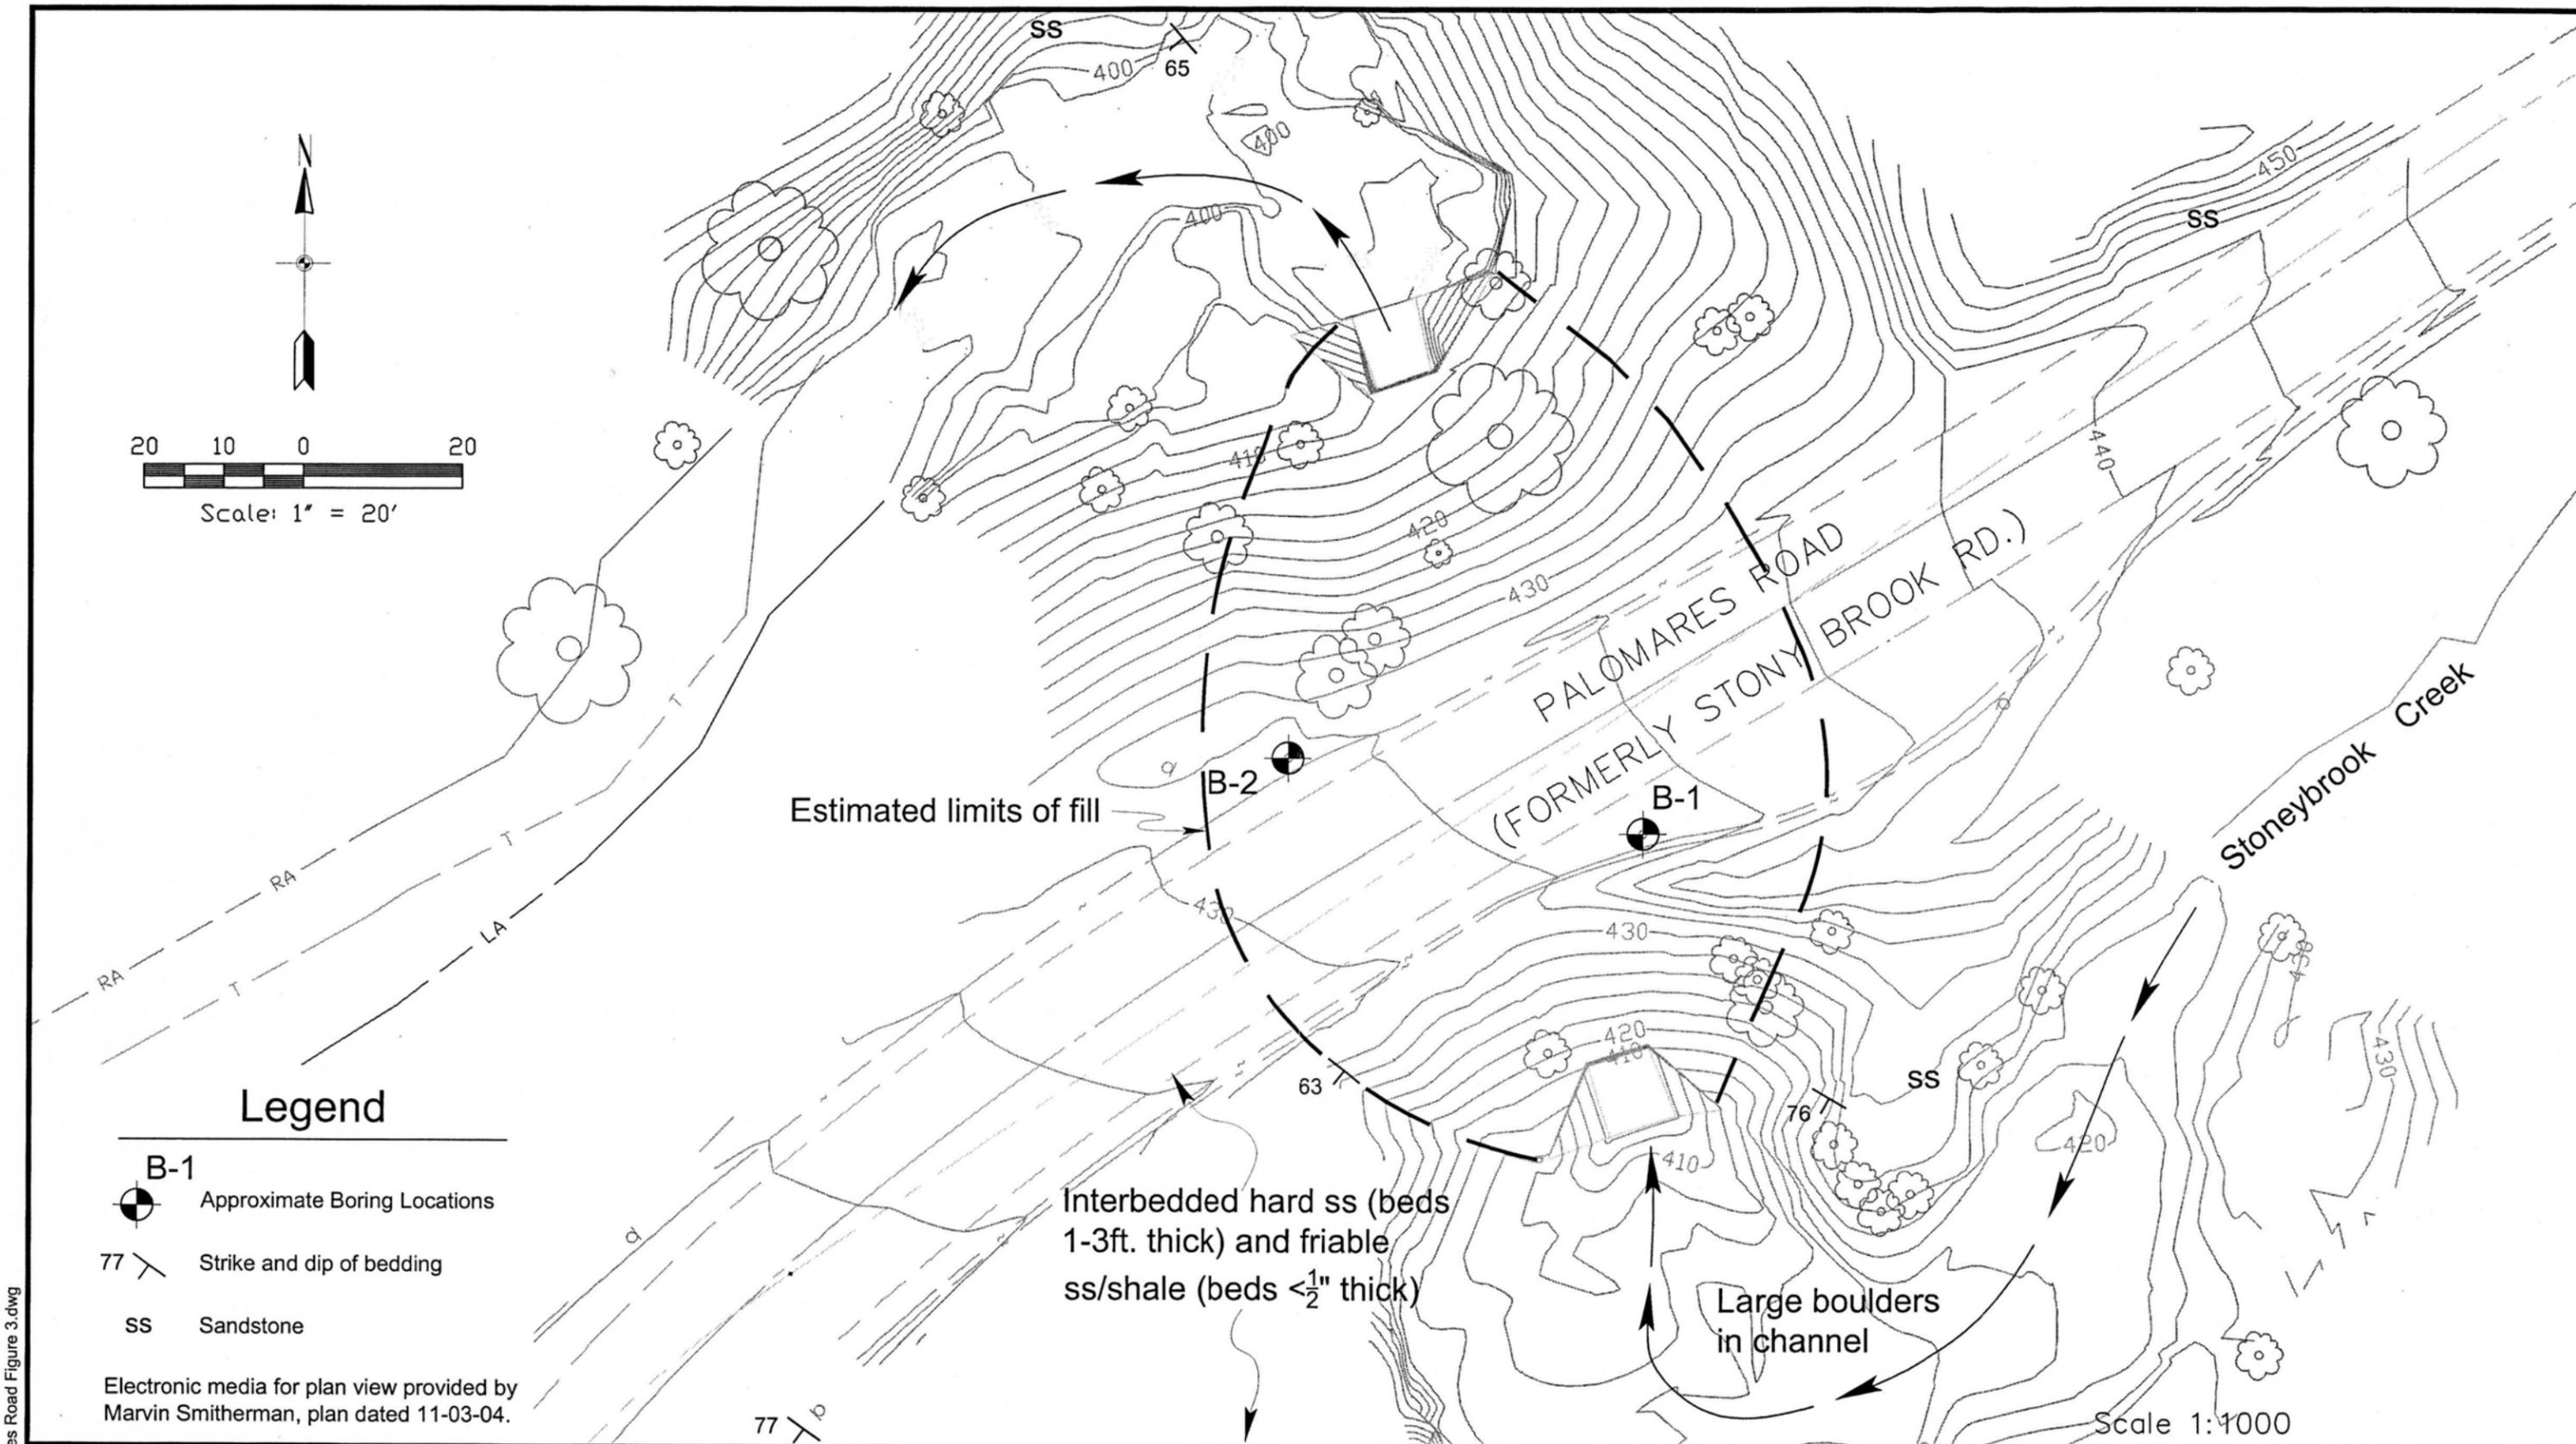
File No. 562.1
Mar. 2005
Figure 3

SITE PLAN
Palomares Road at PM 8.75

- B-1 Approximate Boring Locations
- 77 Strike and dip of bedding
- SS Sandstone

The boring locations are shown on Figures 3 and 4. Detailed logs are included in the Appendix. The degree of weathering and hardness noted on the logs are keyed to the descriptors included in the Appendix.

The test borings at the M.P. 8.75 site encountered loose to medium dense, silty sand and sandy silt, with scattered sandstone fragments, to depth 27 ft in B-1 (southeast abutment, to elev. 405 ft) and depth 20 ft in B-2 (northwest abutment, to elev. 412 ft). We interpret these materials as culvert backfill and young colluvium/alluvium. These soils are unconsolidated, variable in strength, and subject to erosion where exposed.

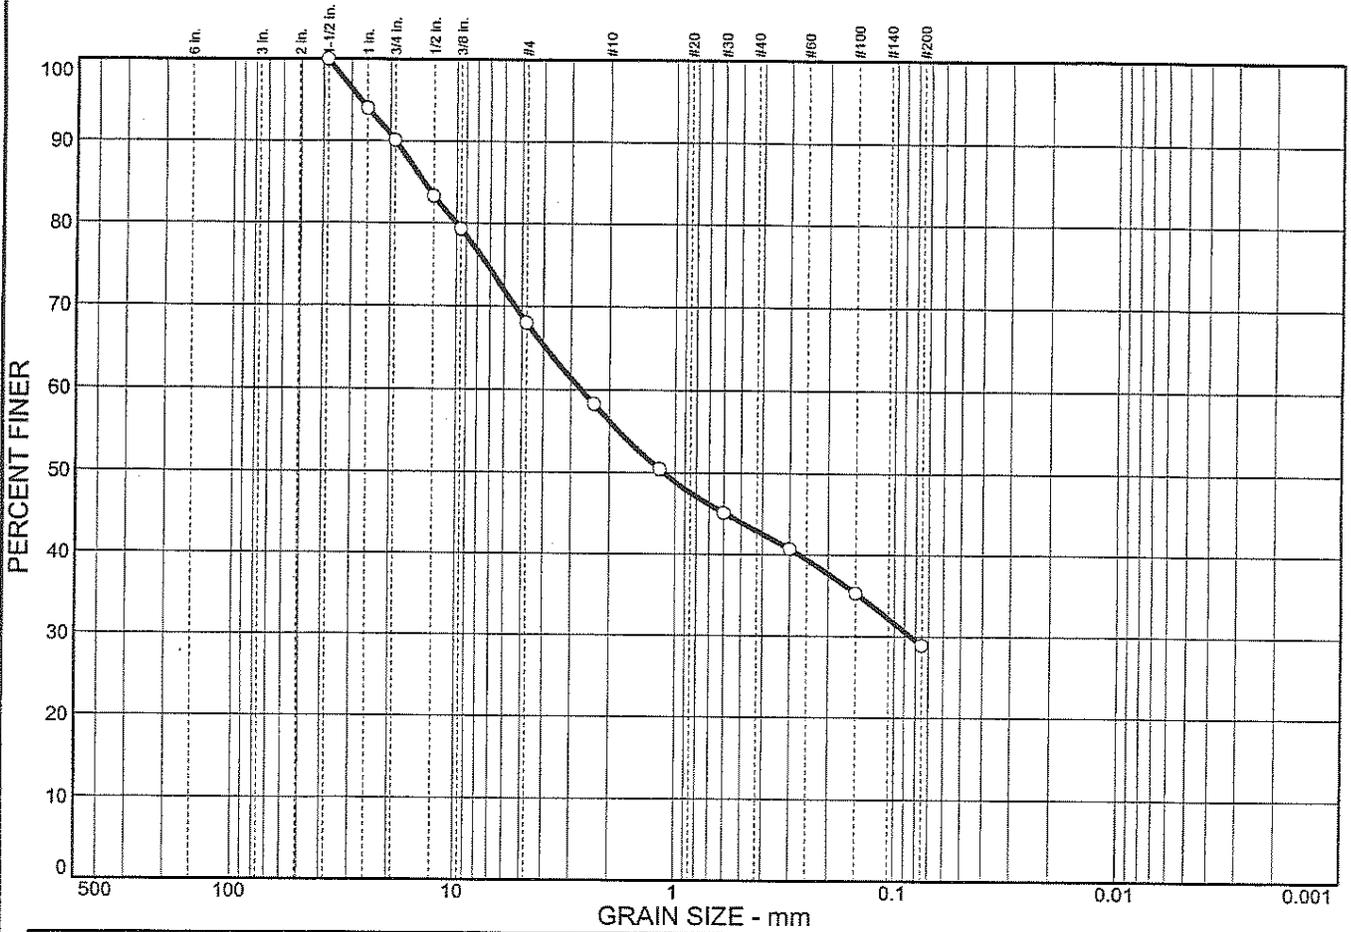
Particle Size Distribution Report

% COBBLES	% GRAVEL	% SAND	% SILT	% CLAY
0.0	32.0	39.1	28.9	0.0

SIEVE SIZE	PERCENT FINER	SPEC.* PERCENT	PASS? (X=NO)
1.5 in.	100.0		
1 in.	94.0		
.75 in.	90.1		
.50 in.	83.3		
.375 in.	79.3		
#4	68.0		
#8	58.3		
#16	50.4		
#30	45.1		
#50	40.7		
#100	35.3		
#200	28.9

The gradation tests indicate the surface soil to be silty sand with gravel with 29% passing 200-mesh sieve (“SM” per Unified Soil Classification). In-place moisture contents range from 6-16%, and dry densities from 103-122 pcf.
