**DRAFT REPORT
CONCEPTUAL ENGINEERING FOR
REMOVAL OF SUNOL AND NILES DAMS**

Alameda County, California

San Francisco Public Utilities Commission

July 2003

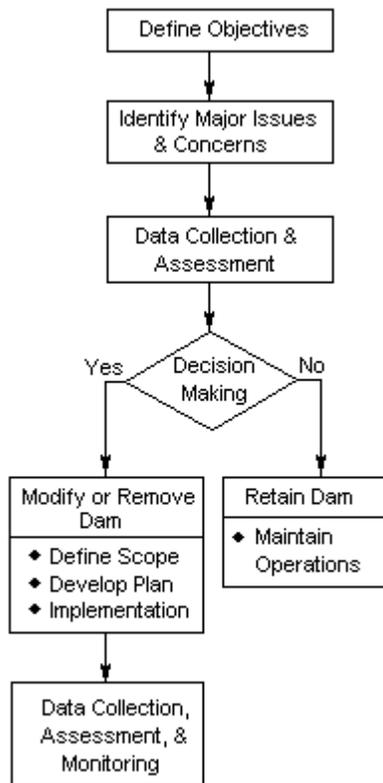
The decision process that is being adopted consists of the following multi-step sequence that includes an “open” decision making process:

1. Define the goals and objectives.
2. Identify major issues and concerns
 - Safety and Security
 - Environmental
 - Legal and Administrative
 - Social
 - Economic
 - Management
3. Data Collection and assessment.

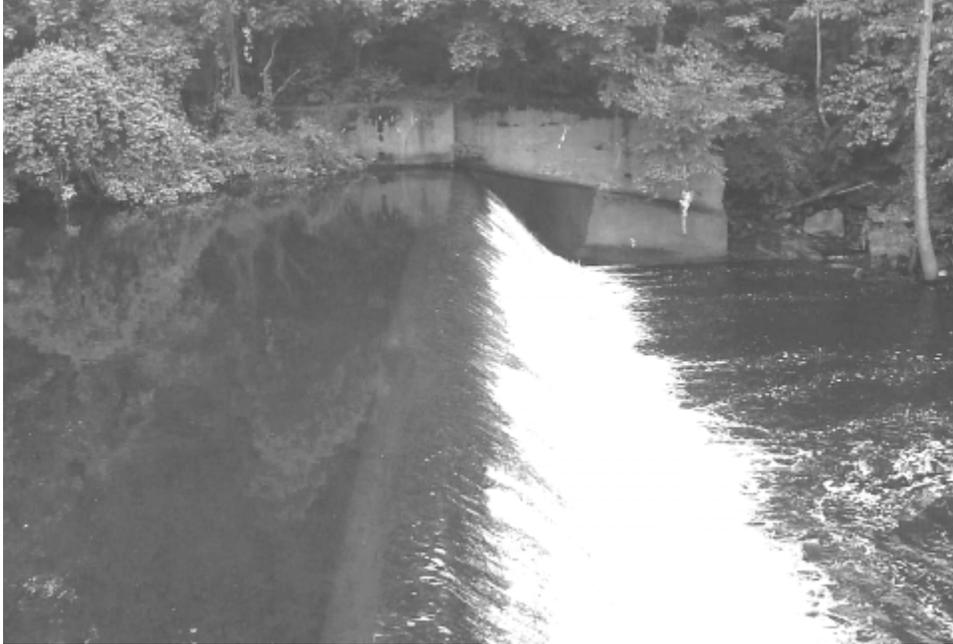
The Old Berkshire Mill Dam (the Dam) was built circa 1915 as a run-of-the-river, concrete gravity dam on the East Branch of the Housatonic River in Dalton, MA (see Figure 1 for photo.) The Dam was constructed to provide hydropower to drive the papermaking machinery in the adjacent Old Berkshire Mill. The concrete dam replaced a timber crib dam, which served the same purpose and was left substantially in place upstream of the 1915 structure. The mill was originally constructed in 1801 by Zenas Crane, founder. Crane owned the Old Berkshire Mill Dam, as well as a series of two dams upstream and three dams downstream. The site locus is shown on Figure 2.

Old Berkshire Mill Dam Old Berkshire Mill Dam was a 130-foot-long concrete structure, which impounded roughly 10 acre-feet of water. The hydraulic height of the Dam, measured to the spillway crest, was approximately 14 feet, and the structural height of the gatehouse/abutment structure was about 22 feet. Based on Massachusetts Office of Dam Safety regulations (310 CMR 10.00), the Dam was classified as Intermediate in size. A dam break model and downstream inundation mapping indicated a Significant hazard classification.

In addition to deterioration of the outlet works, several other deficiencies were identified. Much of the concrete on the downstream face of the ogee spillway section and, in particular, on the abutment / training walls, was deteriorated and spalled. A large depression was found at the toe of the Dam that likely had been created or at least enlarged by scour caused by the hydraulic jump at the base of the ogee spillway. The downstream concrete apron was undermined at this location. The hydraulic analysis indicated that the spillway design flood (100-year return period) would overtop the right abutment/training wall and subsequently overtop the headrace canal earthfill dike.

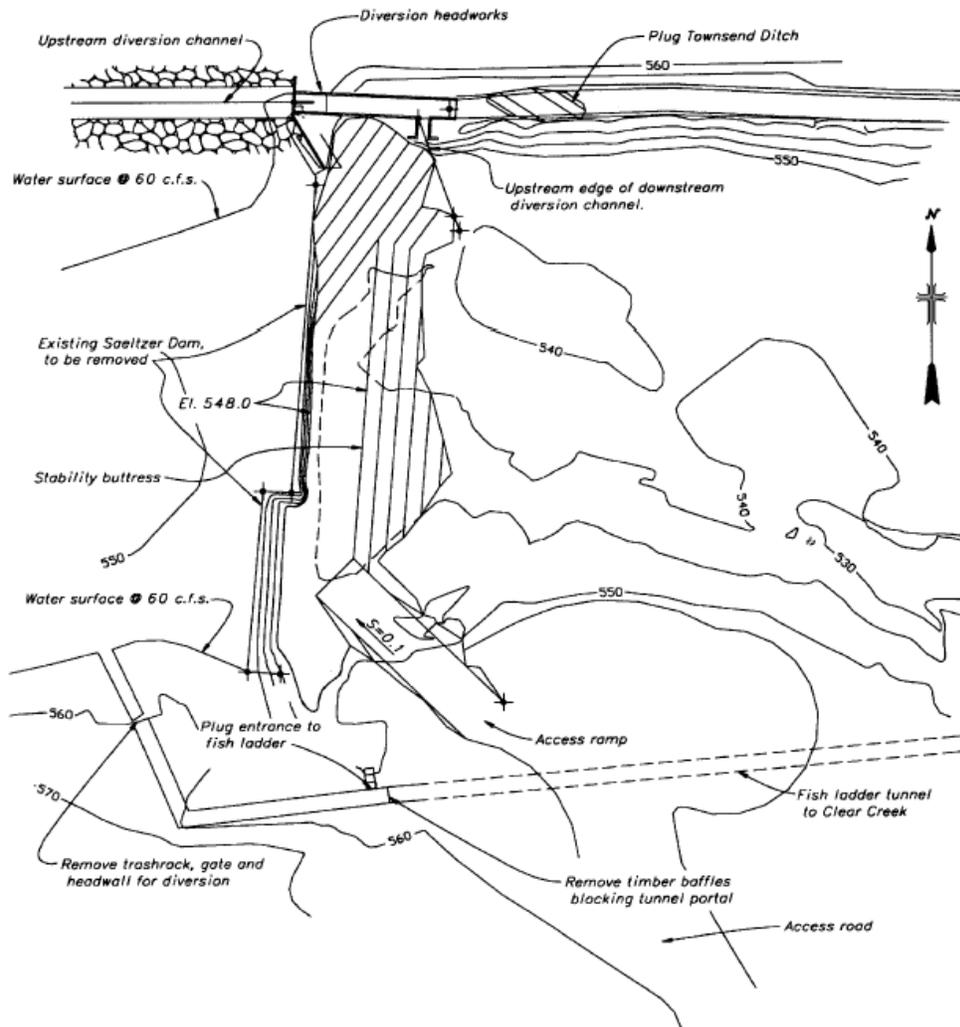
Figure 1. – Plan view of Saeltzer Dam and stability buttress.

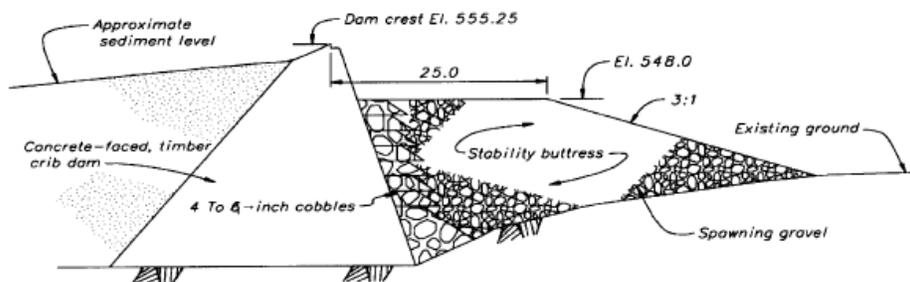
Figure 2. – Cross-section of Saeltzer Dam and stability buttress.

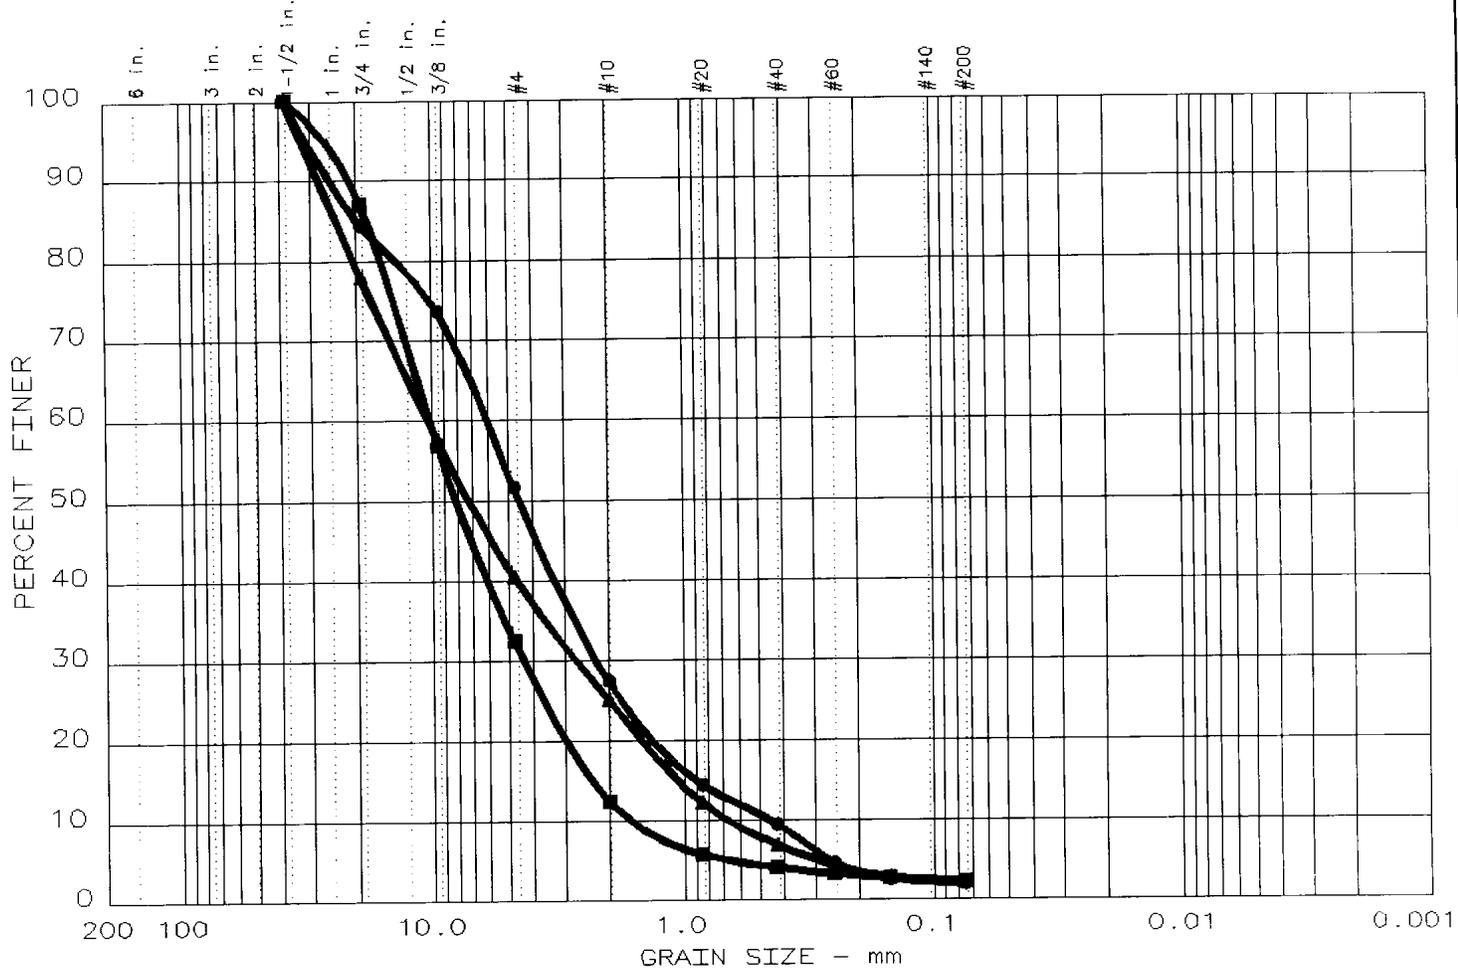
PARTICLE SIZE ANALYSIS (ASTM D 422-63)

% +3"	% GRAVEL	% SAND	% SILT	% CLAY	USCS	LL	PI
●	0.0	48.3	49.6		2.1	SW		
▲	0.0	59.5	38.3		2.2	GW		
■	0.0	67.6	30.1		2.3	GW

SIEVE inches size	PERCENT FINER		
	●	▲	■
1.5	100.0	100.0	100.0
0.75	84.4	78.0	87.0
0.375	73.6	57.4	56.8
GRAIN SIZE			
D ₆₀	6.03	10.45	10.23
D ₃₀	2.24	2.69	4.37
D ₁₀	0.45	0.67	1.64
COEFFICIENTS			
C _c	1.84	1.02	1.14
C _u	13.3	15.5	6.2
